CRAFT POND DAM

NDI ID NO. PA-01103

PHASE I INSPECTION REPORT
NATIONAL DAM INSPECTION PROGRAM

JULY 1981

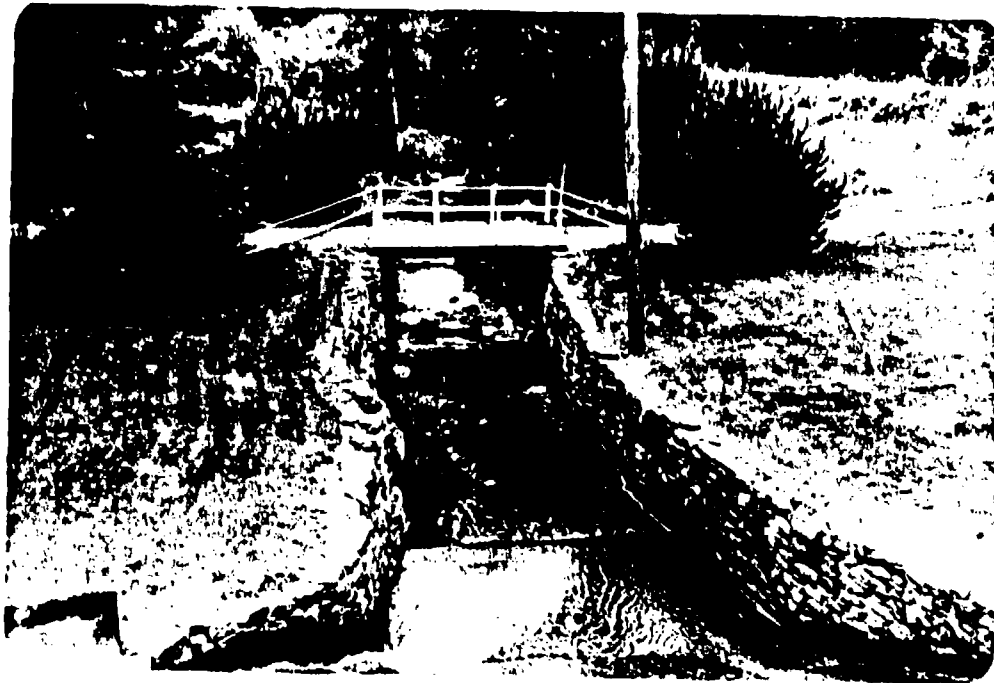
C. Spillway Channel
